SUMMIT LAKE DAM

NDI ID NO. PA-00291

PHASE I INSPECTION REPORT.

APRIL 1979

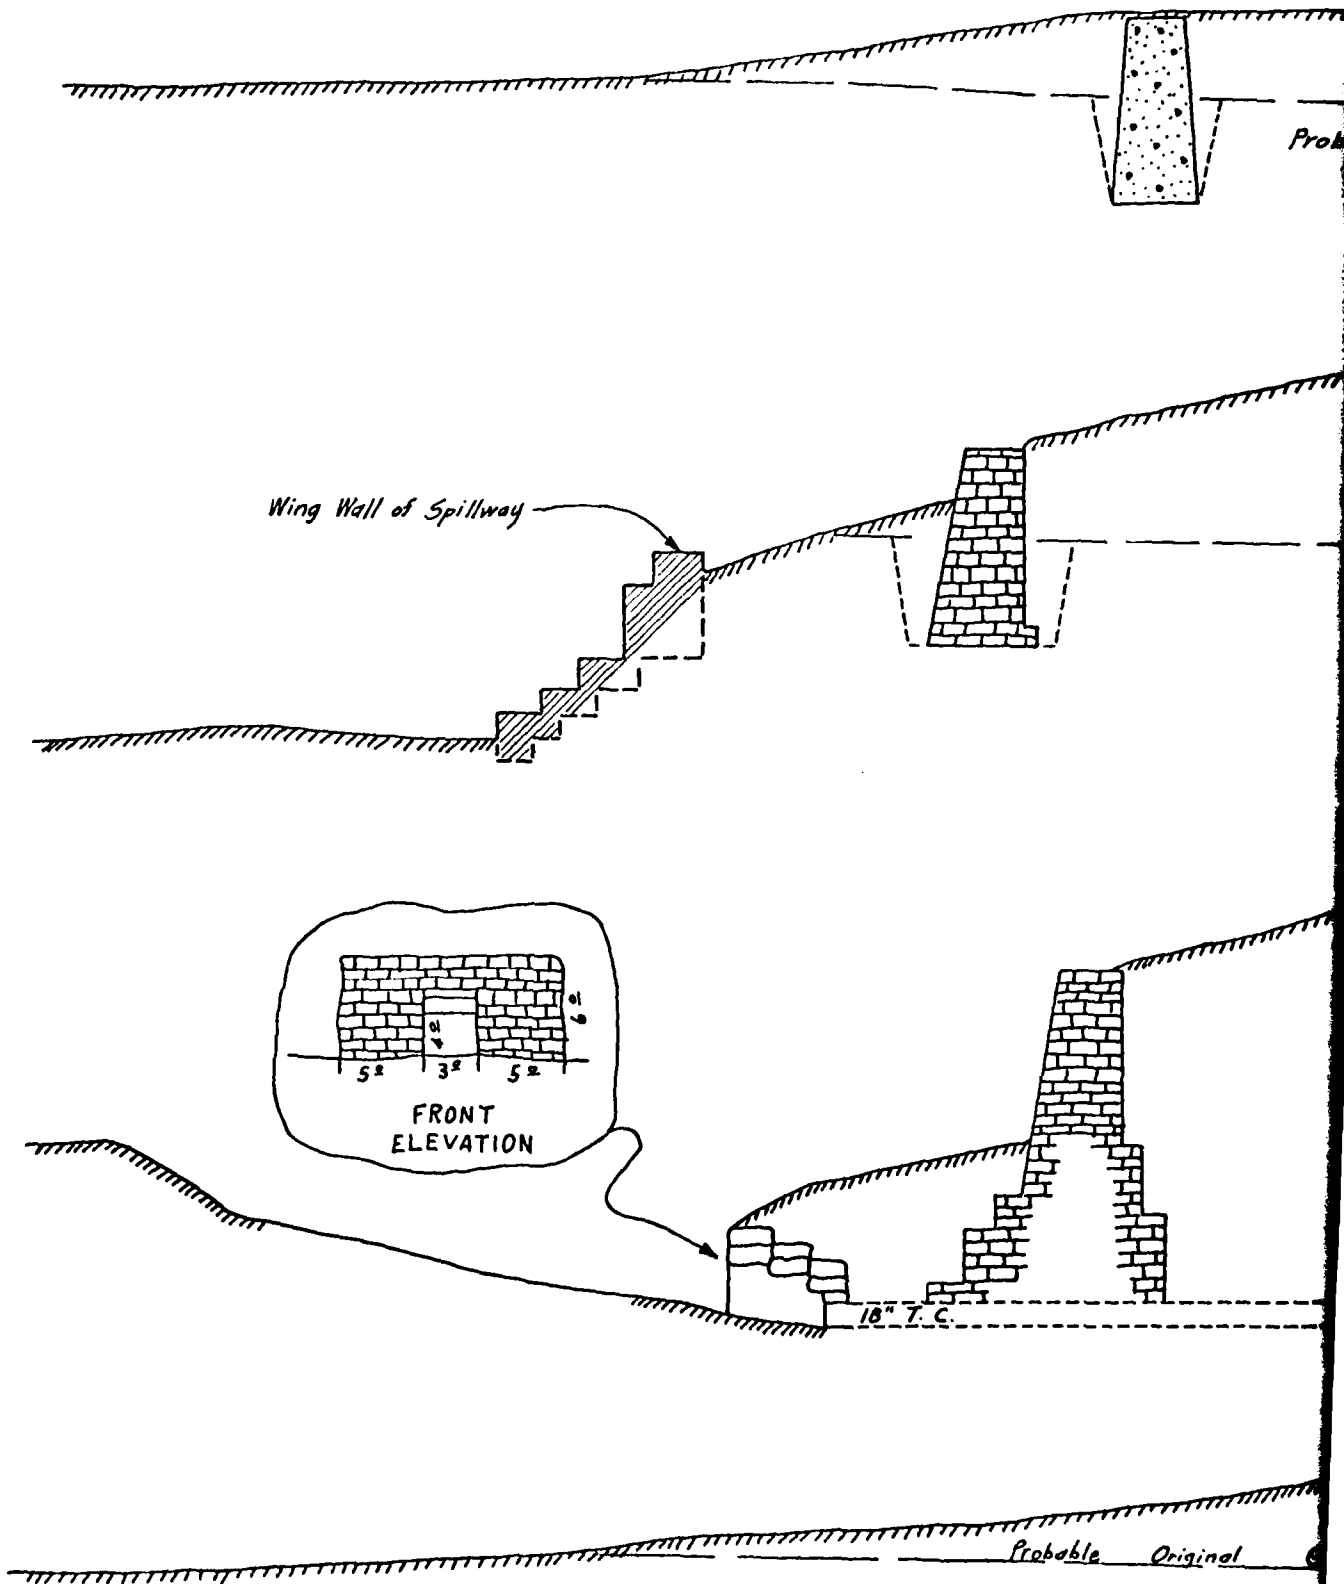
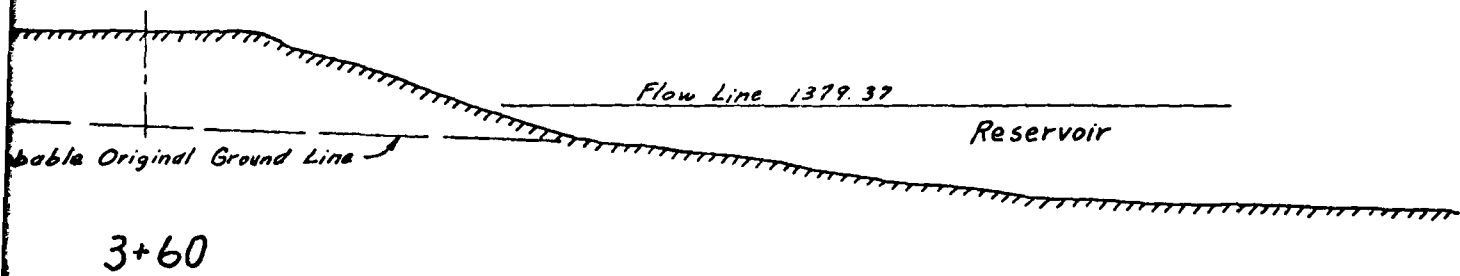
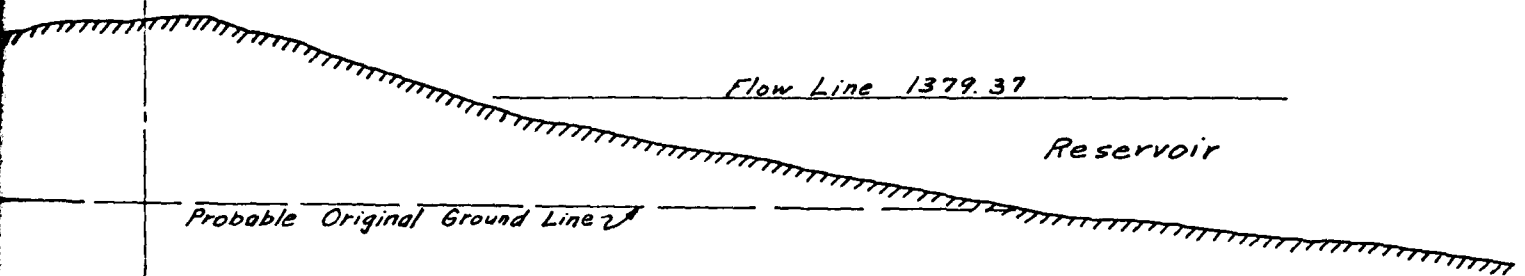
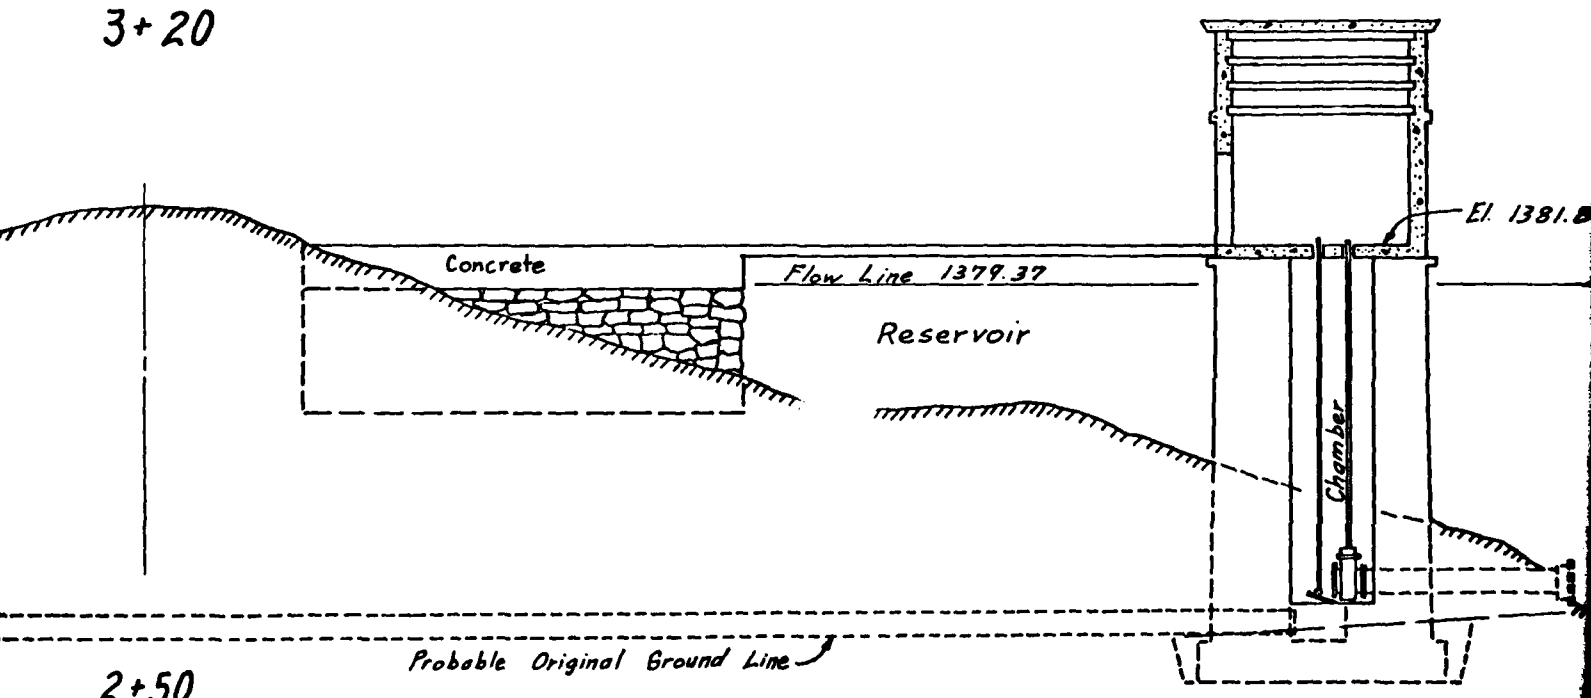
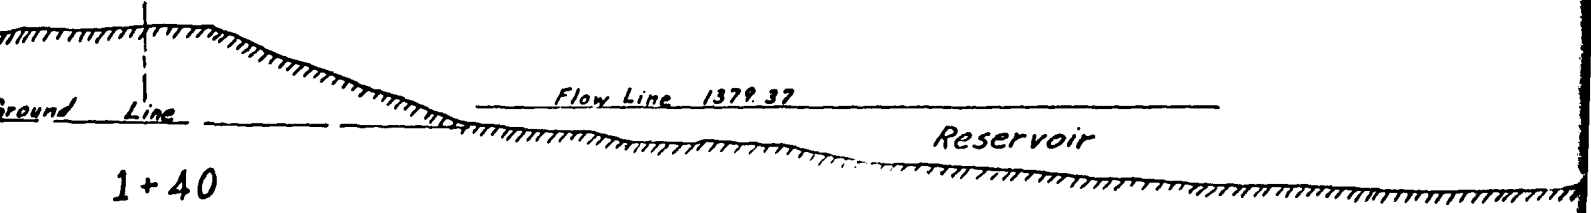
PLATE 3

The highest section of the masonry gravity wall that is shown on Plate 3 was analyzed for this study. Plate 3 was drawn after 1909. It is unsure whether the wall shown on the upper plate is the heavier section referenced above. The stability analysis was performed for the wall, assuming a water level at the top of the wall, full hydrostatic head and at-rest earth pressure on the upstream face, no tailwater, and uplift varying from zero at the toe to two-thirds the headwater at the heel. For this loading condition, the resultant is within the base, but outside of the middle third, about 1.8 feet from the toe, and both the factor of safety against sliding and the toe pressure are within acceptable limits. The OCE guideline for stability states that the resultant should be within the middle
